Manhole Inspection Summary

Manhole # S39AA_018MH

Insp Date: **6/17/08 9:40 AM**

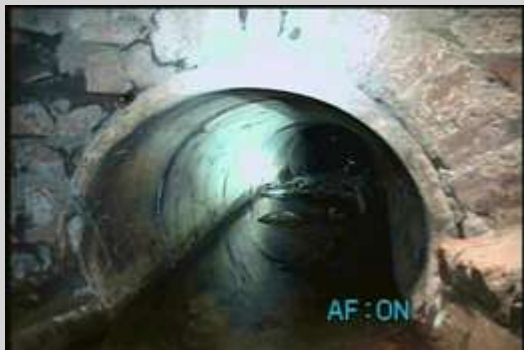
12 O'Clock Outflow

8 in. Circular Gravity Sewer
Pipe Out @ 12 O'Clock

Infiltration: **None** Pipe Seal Cond: **Unknown**
